**Engineering Assessment of Two Cylinders Observed at the Douma Incident
- Executive Summary**

DRAFT FOR INTERNAL REVIEW
Expanded Rev 1 - 27 February 2019

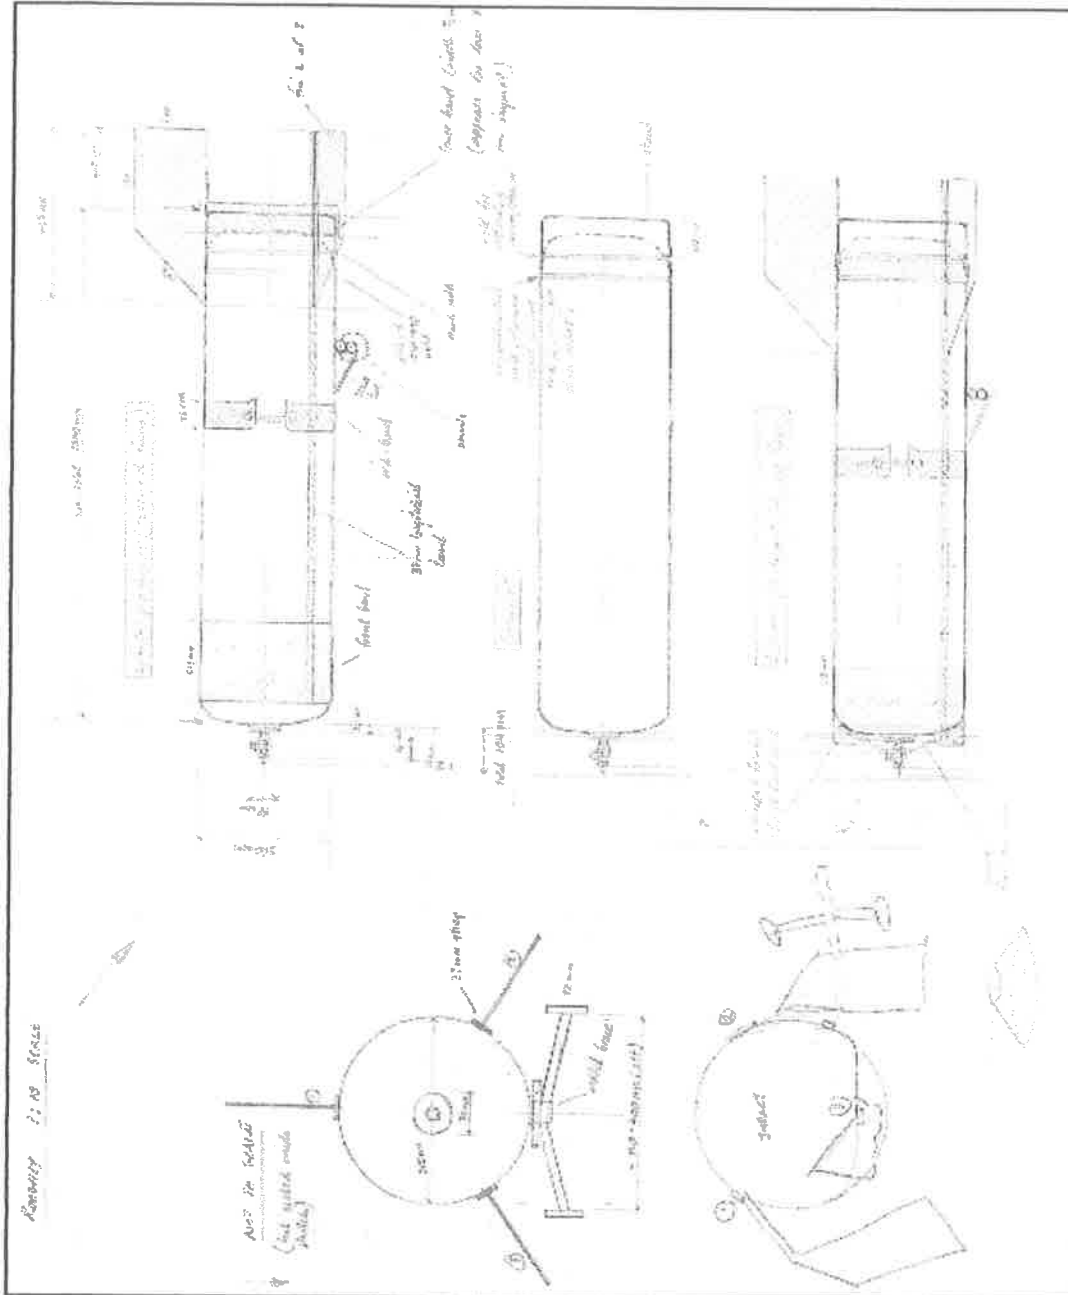
Figure 6: Location 4 cylinder dimensions pre-impact

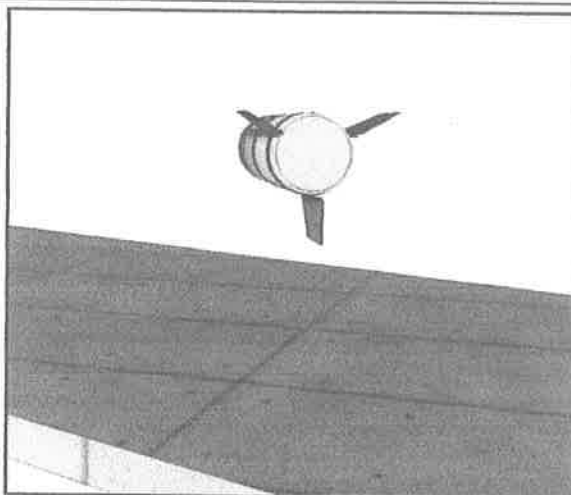
Figure 13: Test case - fin configuration at impact
